T60 Ball Raced Wheeled Runner

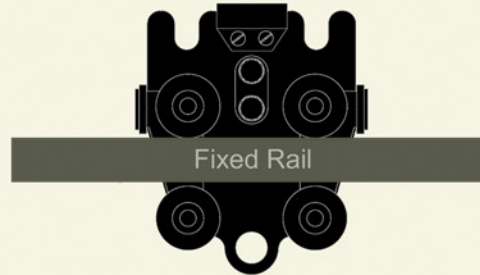
T60 Ball Raced Master Carrier

Load applied at which carrier showed signs of distortion
120KG

Load at which carrier was destroyed

250KG test ended - carrier in good working order.

Applied Load

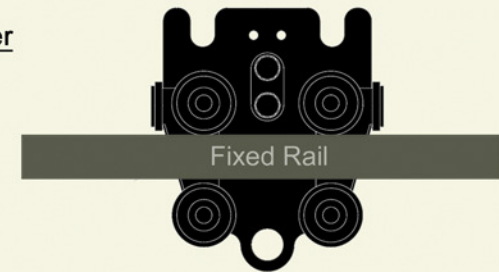
T60 Plain Wheel Master Carrier

Load applied at which carrier showed signs of distortion
165KG

Load at which carrier was destroyed

250KG test ended - carrier in good working order.

Applied Load
